# Batten Kill News

Volume 2, Issue 2

Fall 2001

## Batten Kill Habitat Surveys

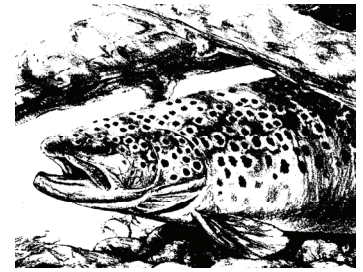
*Illustration by Mike Stidham*

Cover is recognized as one of the essential components of trout habitat. It is defined as areas where fish can find shelter to rest and seek refuge from predators. In streams, cover can take many forms including water depth, surface turbulence, coarse substrate (e.g., boulders and cobbles), undercut streambanks, aquatic and overhanging riparian vegetation, woody debris (e.g., log snags and roots), and any other structures that provide fish with a secure place to conserve energy or evade threats. A stream or river lacking adequate cover, even though all other habitat requirements (water quality, temperature, food, and spawning areas) are met, is a poor place for trout to live over the long term and will usually be reflected by lower population densities. Adult brown trout are very dependent on the presence of cover and are largely confined to it except when feeding and spawning. Research has shown brown trout prefer cover that is associated with locations low in the water column, and provide tactile stimulation and low light conditions.
