# Batten Kill News

Volume 3, Issue 1

Winter/Spring 2002

## Highlights of 2001 Projects

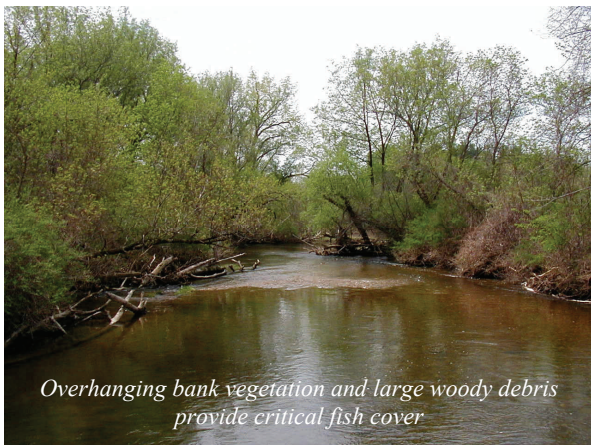
*Overhanging bank vegetation and large woody debris provide critical fish cover*

overhanging bank vegetation. When water depths two feet or greater are not factored in, overhanging vegetation provides on average about 76% of the trout cover. As might be expected, pool habitat units contain the greatest amount of cover, particularly when deep water is also taken into account. Nearly three-quarters of the pools evaluated have sufficient depth (two feet or greater) to serve as trout cover. Other types of cover identified within Reach 1 are woody debris (e.g., logs and root wads, wood aggregates); boulders; bank revetments and undercuts; and pocket water.

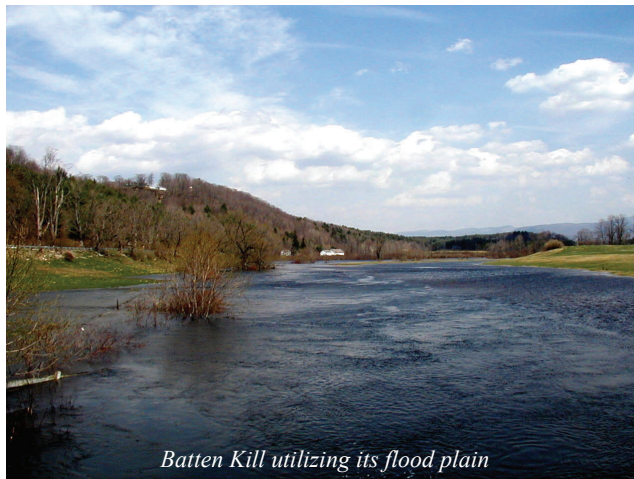
*Batten Kill utilizing its flood plain*

Naturally stable streams in broad valleys or otherwise unconfined settings have access to their floodplains. Energy from the stream can then be dissipated as the water flows over the banks and into the floodplain – a process that allows the water to spread out and slow down, thereby reducing the downward erosion on the stream bed during floods. However, even these types of streams benefit from the existence of woody vegetation on their banks and in their floodplains. Such vegetation further dissipates the energy associated with flowing water. Streams that are unstable and lack access to their floodplains, then, experience more downward erosion of their stream bed. Riparian vegetation helps these streams by binding the stream banks with roots to protect against the strong force of water.
