Batten Kill Watershed Alliance

P.O. Box 734
Arlington, VT 05250

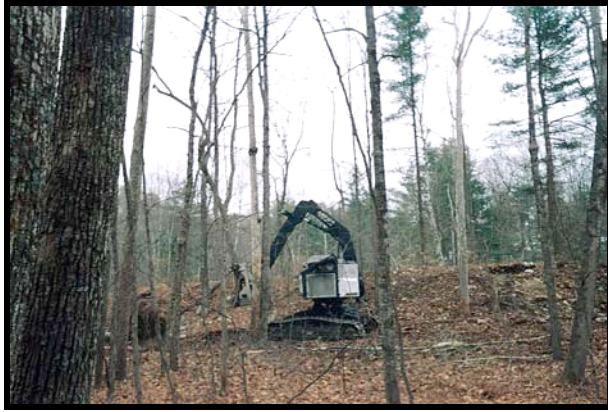
Bruce Waite and his 'feller-buncher' seizing a tree to pull it out. Note the height of the berm in the background.

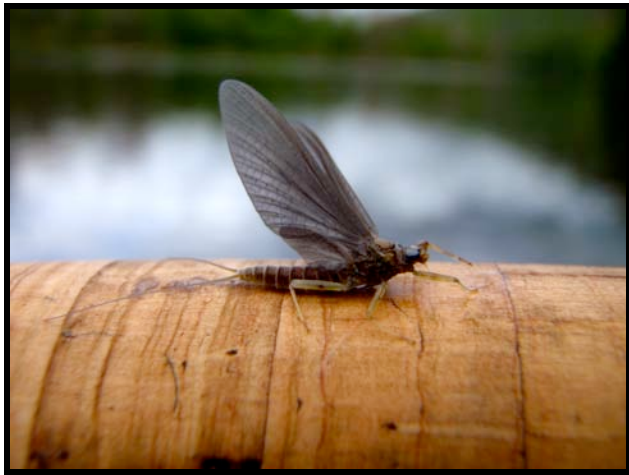
Batten Kill watershed, fifty were ranked good, very good, or excellent. Excellent means as good as a natural stream without degradation from changes in land use or

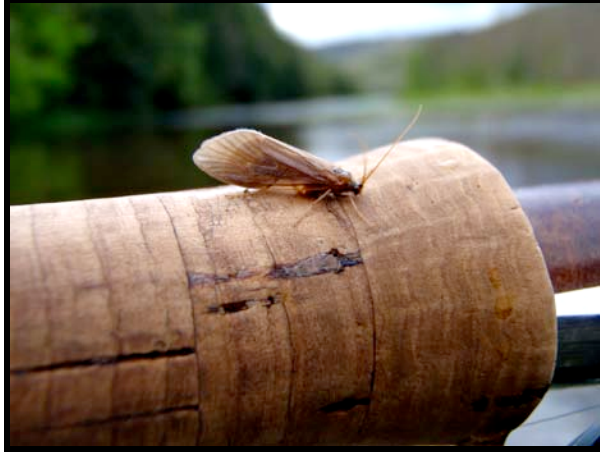
By the way, speaking of conditions in the river: the creamy bubbles and foam visible in the Batten Kill at times result from gases related to the natural processes of decaying organic matter. They do not represent pollution or a bloom of invasive algae.
